# **ENVIRONMENTAL EXPOSURE OF JG-PP/JCAA TEST PWAS**

Prepared On: January 31, 2005

By: American Competitiveness Institute  
One International Plaza; Suite 600  
Philadelphia, Pennsylvania 19113

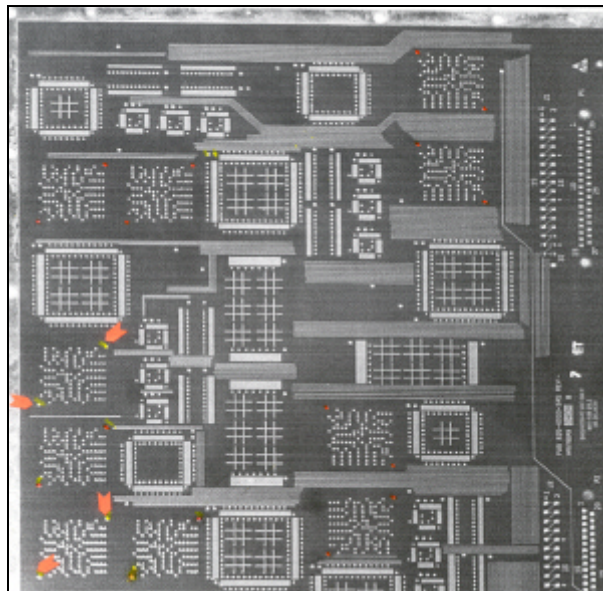
Figure 1. Test board with arrows for continuity check of CT-BGAs, bottom side.

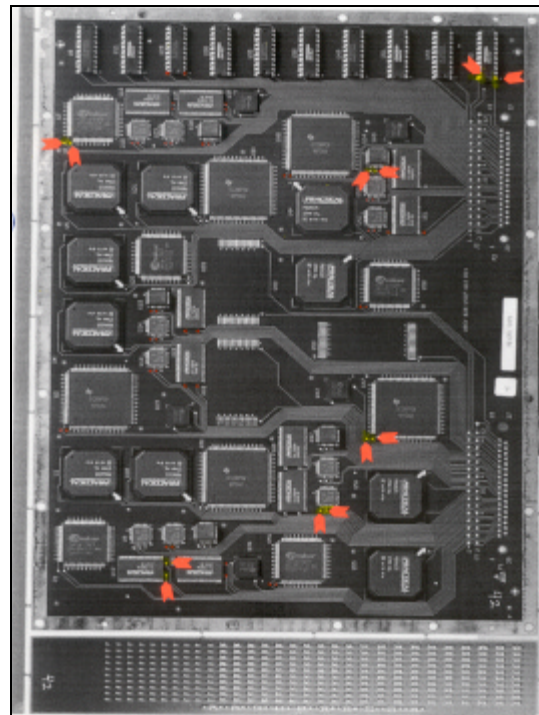
Figure 2. Test board continuity check, top side.  
Points indicate where continuity tests were performed

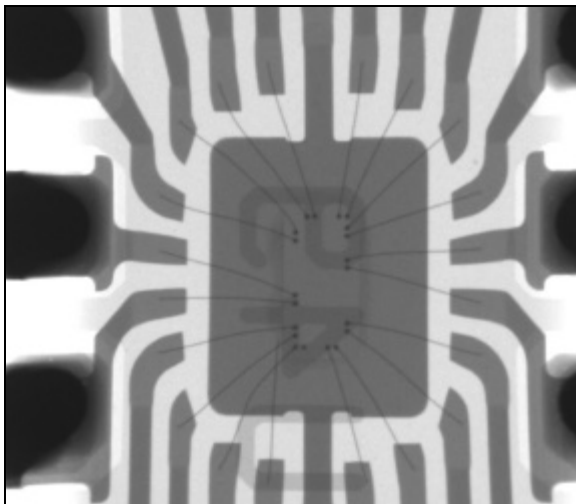
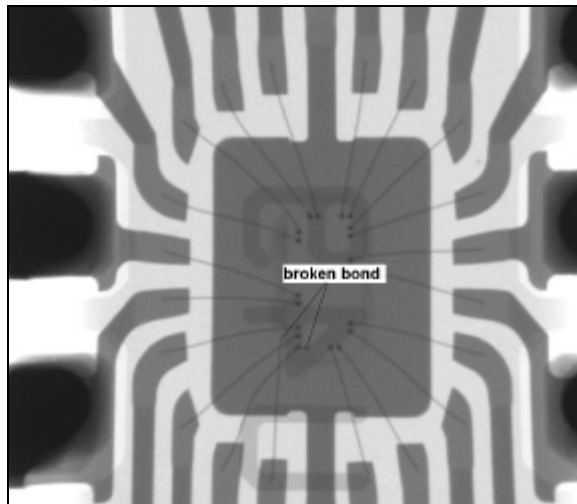
- ? There was an open found between the ninth and tenth pins on the component. Those two pins were supposed to be shorted within the component.
- ? The open circuit was caused by a broken bond within the chip. This can be seen in the X-ray images (Figures 3 and 4).

Board 38: Component U49: The open circuit was caused by a broken bond within the chip.

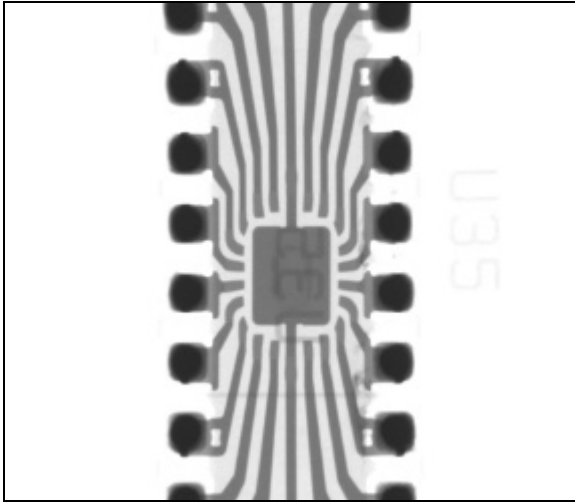
Figure 5.

- ? Component U35 showed open circuits where the component leads were supposed to be in series (daisy chained). X-ray analysis of this component revealed die with no internal wire bonds to the lead frame. Figure 5 is an X-ray image of the component showing no internal wire bonds. Figure 6 is the same component on board number 105 showing wire bonds properly attached to the die.

Board 104: Component U35: Open circuits where the component leads were supposed to be in series (daisy chained).

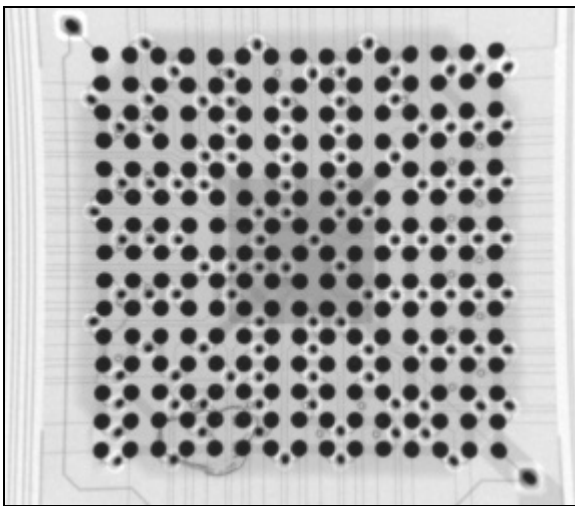
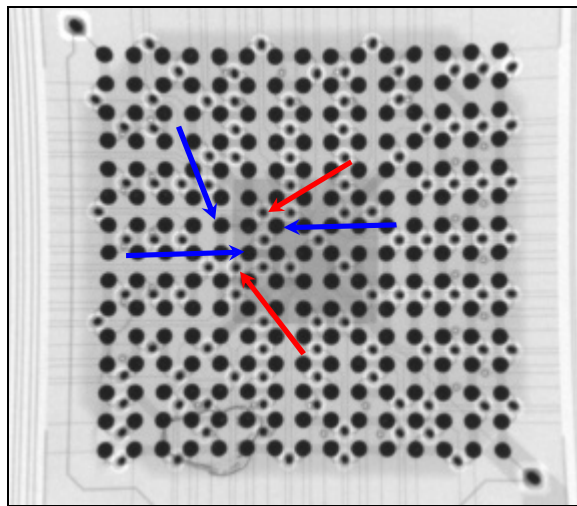
- ? Continuity testing prior to and after the salt atmosphere exposure showed that there was an open circuit within the component (Figure 7). The location of the open circuit was identified between the two via locations marked with red arrows on Figure 8. The two should be electrically connected through the 3 BGA balls marked with blue arrows in Figure 8. Figure 9 is an image of the questionable area of component U56. There is a significant amount of voiding which may contribute to the open circuit. Figure 10 is an image of U55, a properly working component of the same model on the same board. There are significantly less voids in the solder in this component than on U56.

Board 104: Component U56: Continuity testing prior to and after the salt atmosphere exposure showed that there was an open circuit within the component.

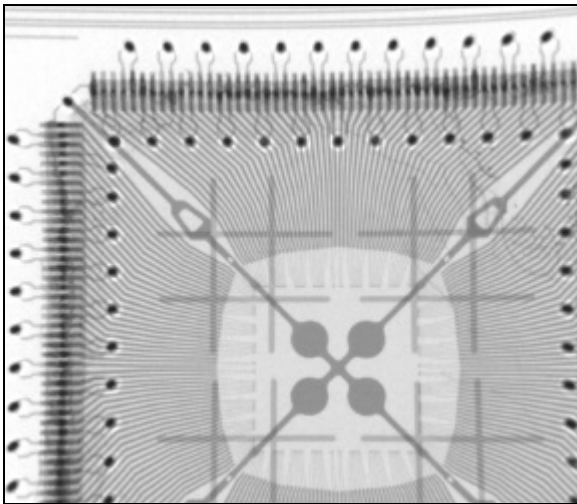
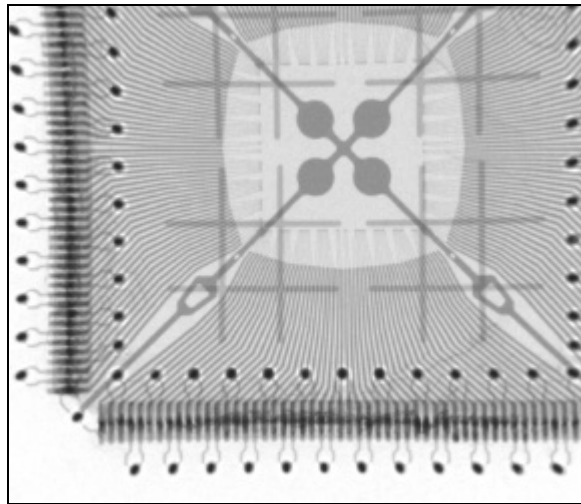
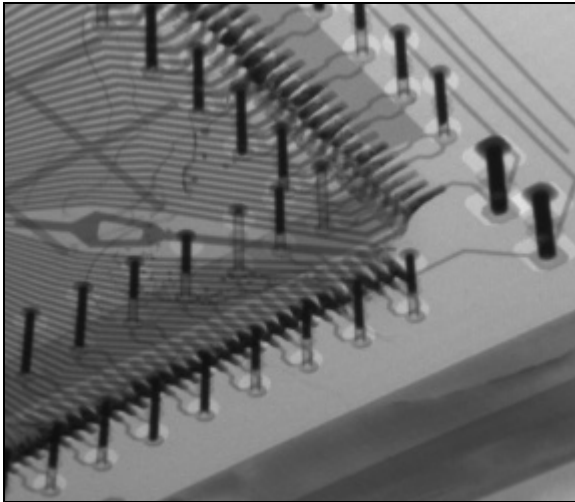
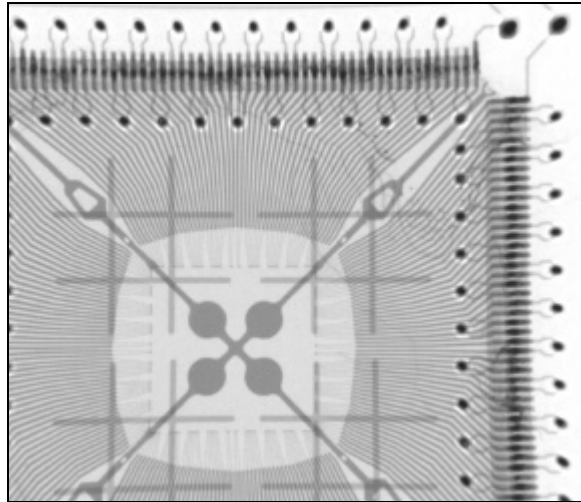
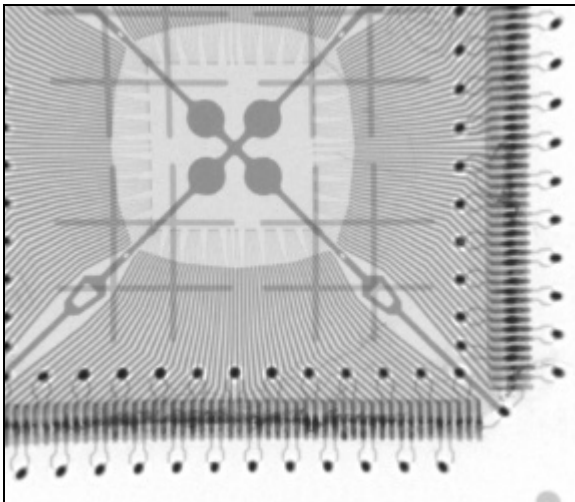
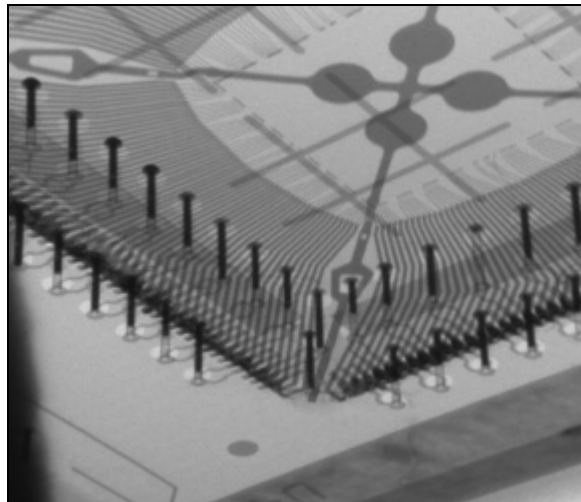
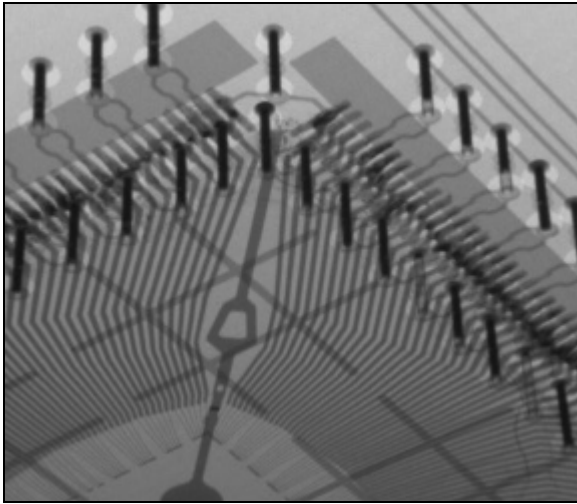
- ? There was a resistance reading of 70.6  $\Omega$  across the terminals of the component indicating an improperly wired component.
- ? The X-ray images show what could be solder thickness issues of the legs on the board as they seem to change throughout the whole part.
  - Figure 11: (60kV 50 $\mu$ A) Board 105 debris U3 bottom left corner top down
  - Figure 12: (60kV 50 $\mu$ A) Board 105 debris U3 bottom right corner top down
  - Figure 13: (60kV 50 $\mu$ A 45° + rotation 55° Oblique) Board 105 debris U3 pin 1
  - Figure 14: (60kV 50 $\mu$ A) Board 105 debris U3 pin 1
  - Figure 15: (60kV 50 $\mu$ A) Board 105 debris U3 upper right corner top down
  - Figure 16: (60kV 50 $\mu$ A 45° + rotation 55° Oblique) Board 105 debris U3 upper right corner
  - Figure 17: (60kV 50 $\mu$ A 45° + rotation 55° Oblique) Board 105 debris U3

Board 105: Component U3: There was a resistance reading of 70.6  $\Omega$  across the terminals of the component indicating an improperly wired component.

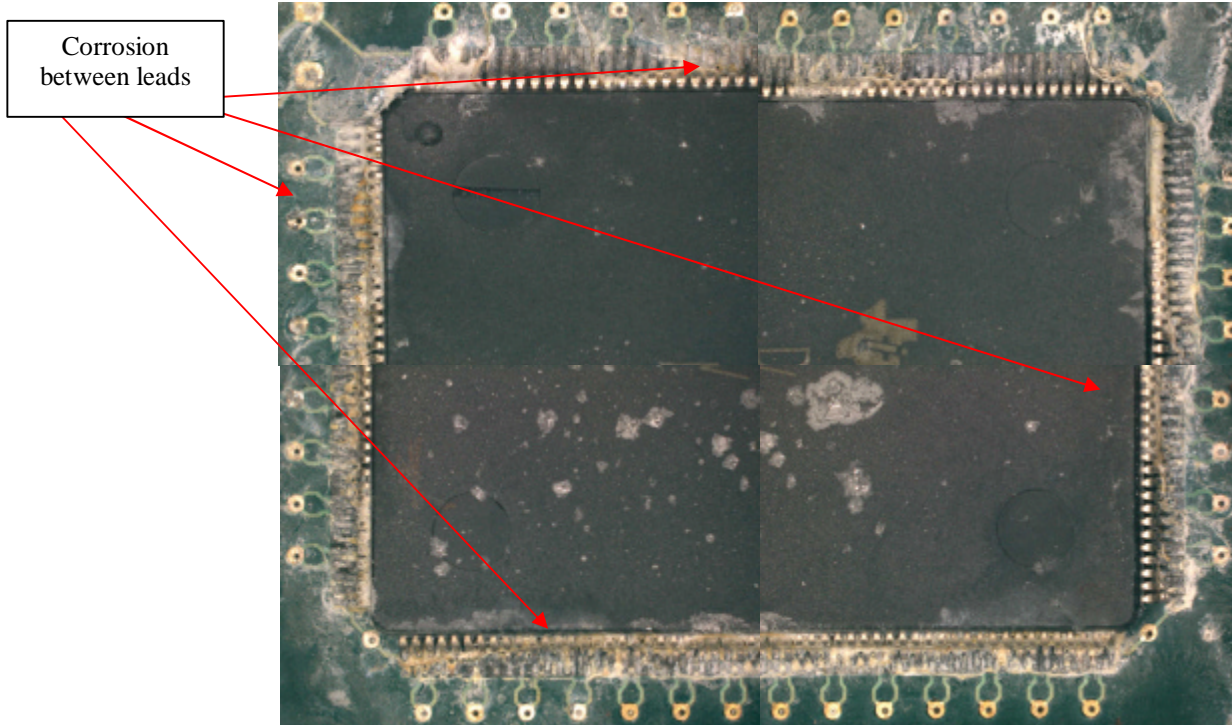
Figure 18. Optical image of QFP U3 from board 105 at 7X.

Corrosion of nearby traces or underlying balls

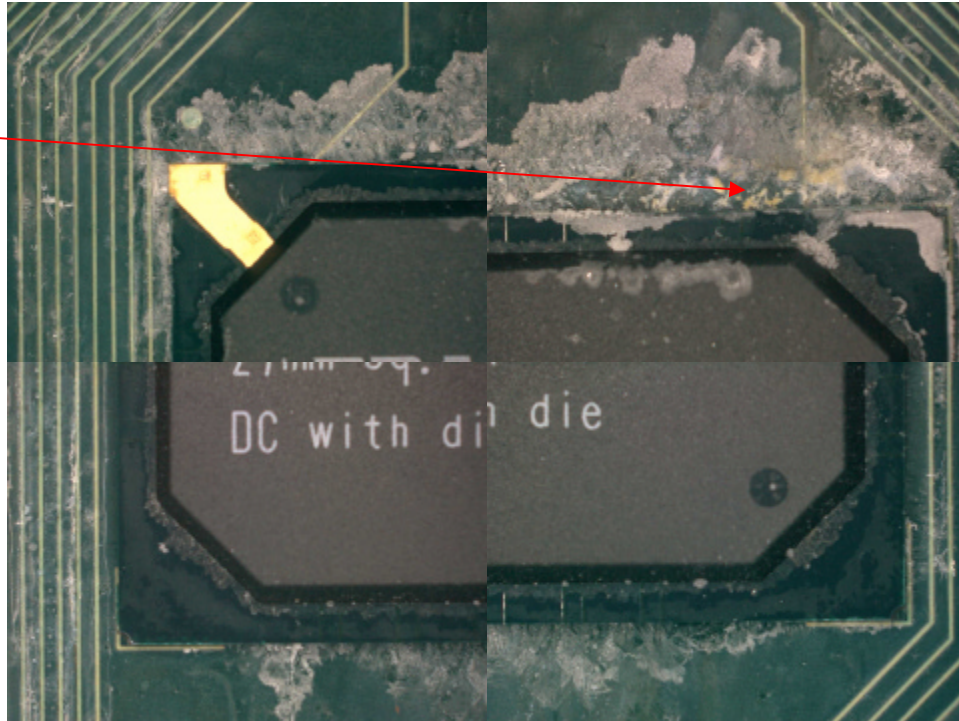
Figure 19 Optical image of BGA U56 from board 104 at 7X.

Corrosion between leads

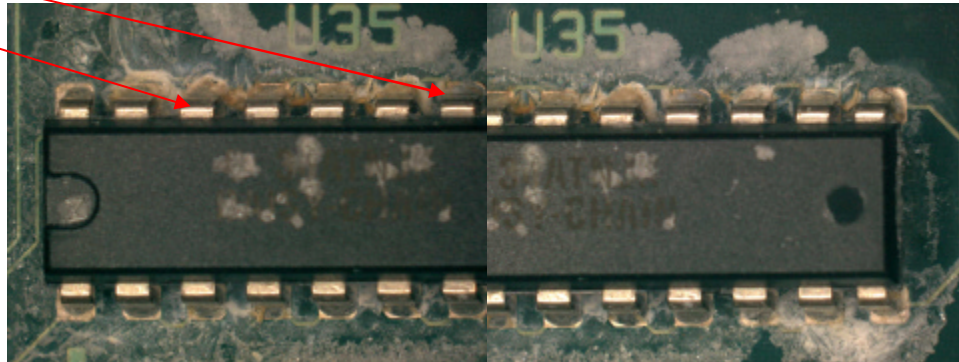
Figure 20 Optical image of SOIC U35 from board 104 at 7X.

Visual inspection of failed salt atmosphere components exhibited corrosion between the leads. This level of corrosion was consistent between all boards and components.
